**RECOMMENDATIONS FOR RISK  
ASSESSMENTS OF ICE THROW AND  
BLADE FAILURE IN ONTARIO**

Client	<b>Canadian Wind Energy Association</b>
Contact	David Timm
Document No	38079/OR/01
Classification	Client's Discretion
Date	31 May 2007

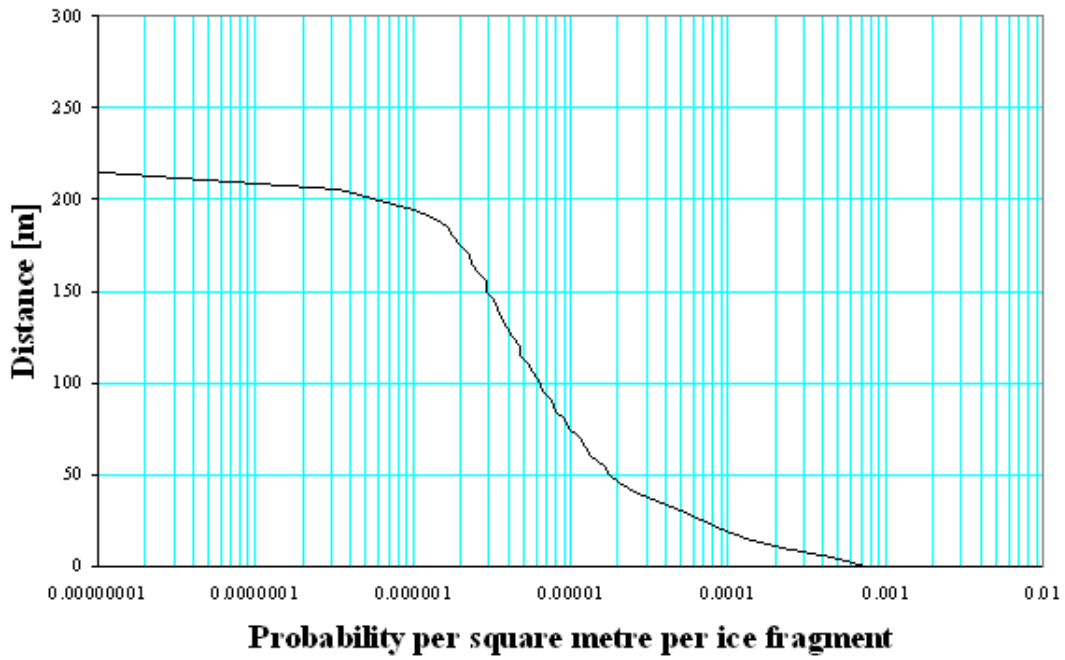
**Figure 3.2** Calculated probability of ice fragment throw distances

The results are shown in Figure 3.2. This represents the probability, given an ice fragment has been released, that any one ice fragment lands in one square metre of ground area, as a function of distance from the turbine. Clearly the risk per square metre per year is obtained by multiplying by this probability by the probability of a fragment being released, which in turn depends on the number of ice fragments thrown from the turbine per year.

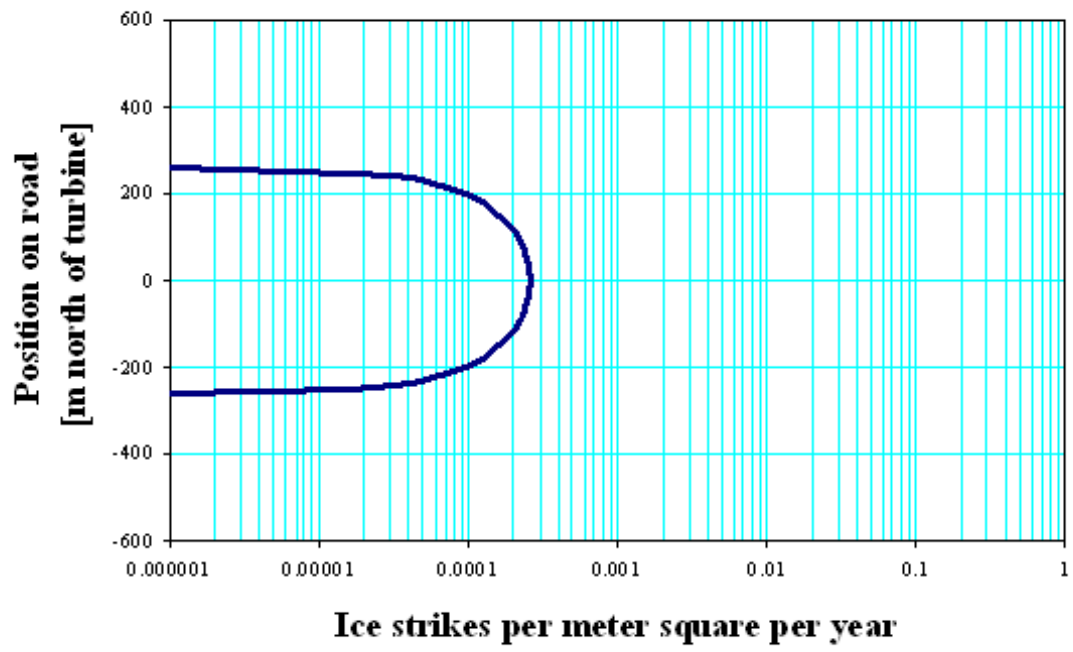
Figure 3.8 Risk profile for Scenario B

- From Figure 3.4 for moderate icing conditions, the risk profile on the road can be plotted as presented in Figure 3.8.
- It is assumed in a rural setting that 100 vehicles traveling at 60 kilometer per hour will pass the turbine during the 5 days of icing events. From Figure 3.8, a vehicle would be exposed to hazard for a conservative 600 m segment of the road. Therefore, the fraction of time that a vehicle would be exposed to hazard is:

- Calculating the area weighted average under the risk profile of Figure 3.8 and assuming that wind directions resulting in a turbine rotor alignment with the road occur 30% of the time during icing conditions, the resulting IR for a vehicle with a plan area of  $10 \text{ m}^2$  would be:
